Examination of Components from a Failed Marine Engine

Report Number	M14191
Date	XXXXXXXXXXXXXXXXXXXX
Purchase Order Number	XXXXXXXXXXXXXXXXXXXX
Customer Reference Number	XXXXXXXXXXXXXXXXXXXX
Customer	XXXXXXXXXXXXXXXXXXXX XXXXXXXXXXXXXXXXXXXX XXXXXXXXXXXXXXXXXXXX XXXXXXXXXXXXXXXXXXXX XXXXXXXXXXXXXXXXXXXX
Customer Contact	XXXXXXXXXXXXXXXXXXXX

1. Introduction

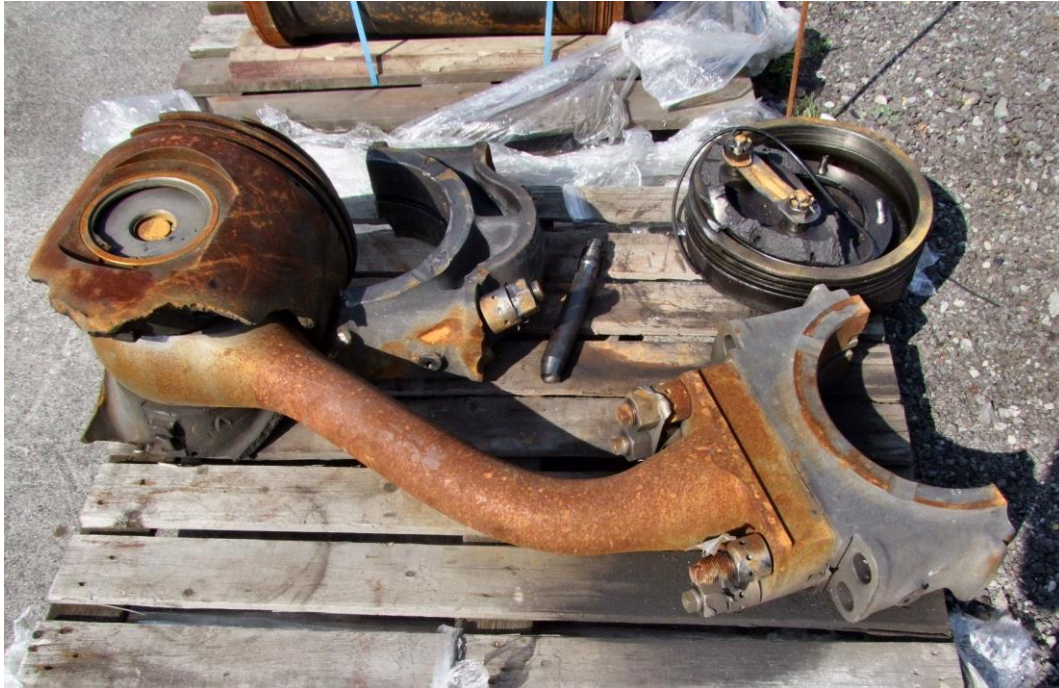
Figure 1.1 Conrod, piston and bolt as received

The conrod was bent and the piston had fractured into two pieces. More detailed images of these are shown in section 2 below. The incident had occurred whilst the vessel was proceeding on passage and the engine was just re-started following an unscheduled stop to change a damaged / leaking fuel injector pipe. XXXX also informed R-Tech that they had learnt that the engine had also been in an over-speed situation one month prior to this, with no resulting failure. They had also been informed that no inspections of the bolts and fastenings had taken place once the engine had been stopped, and also that no parts were changed after this earlier over-speed incident. This earlier occurrence happened on completion of a major strip-down and overhaul when the engine was being test-run. In neither case did the automatic over-speed protection devices operate. The engine is a six cylinder turbo-charged XXXX medium speed diesel engine developing 2677kW at 600 rpm MCR (maximum continuous rating). The engine had run for a total of 166575 hours, with 559 hours subsequent to the last major overhaul. The failure during the second over-speed resulted in the piston breaking out through the cylinder liner.

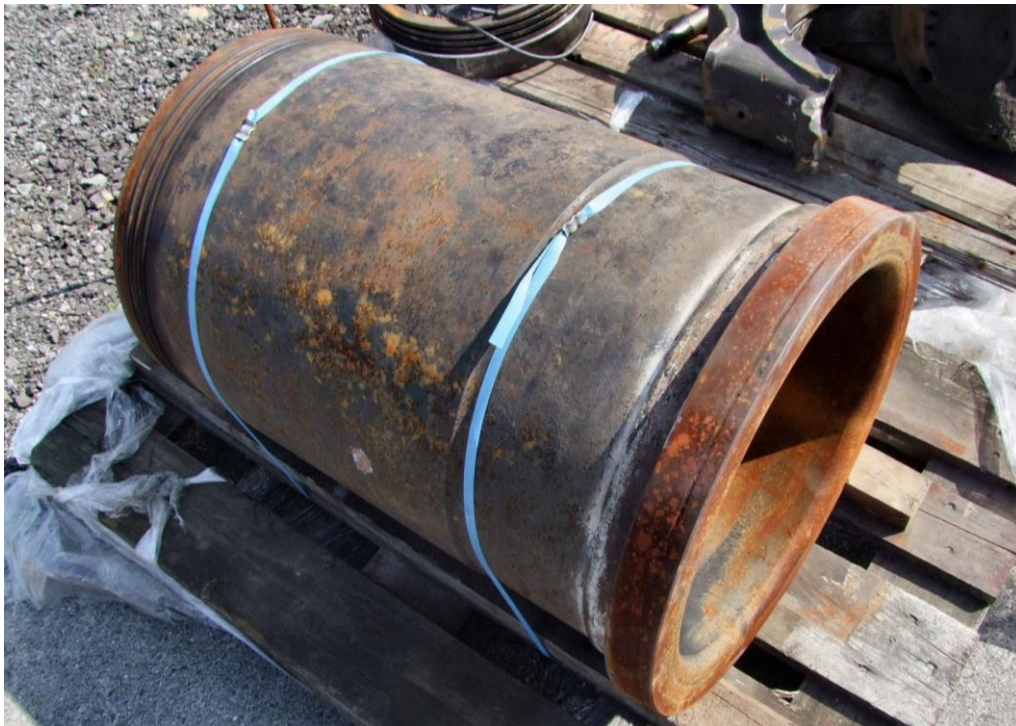
Figure 1.2 Cylinder as received

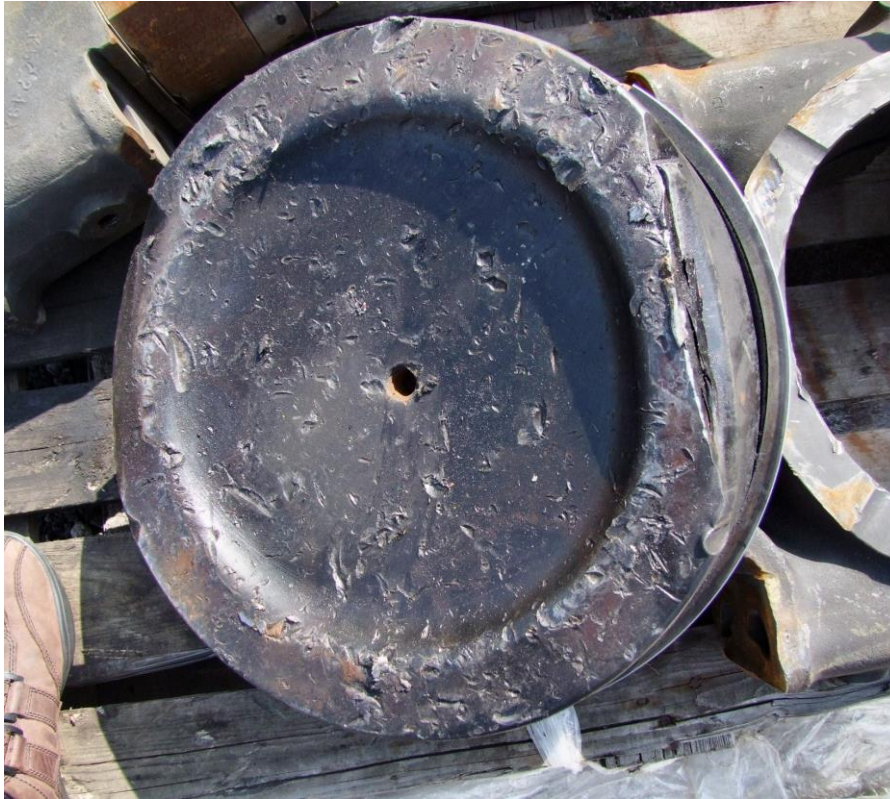
Figure 2.1 Piston working face

The piston working face shown in figure 2.1 has many areas of mechanical damage present on it. The underside of this top piece of the piston shown in figure 2.2 has a granular appearance to the fracture face that is present. This fracture face matches up with that shown in figure 2.3 on the upper end of the lower piece of the piston. It is evident that the fracture of the piston has occurred in a brittle manner with no deformation.

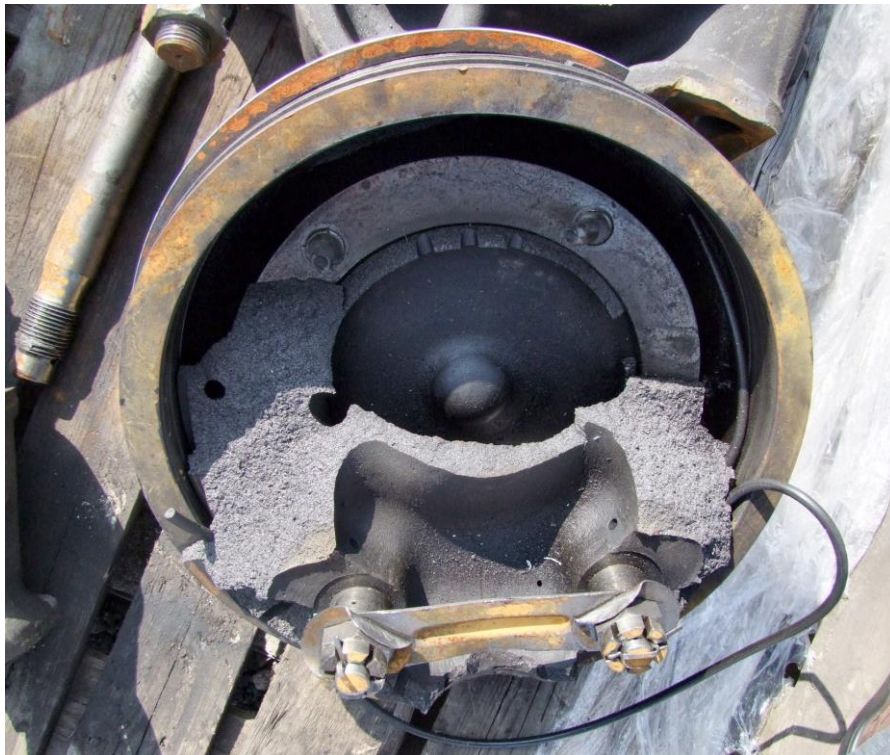
Figure 2.2 Top piece of piston, showing the underside fracture face

Two failed piston crown studs had failed in a purely tensile manner and are shown in figures 2.8 to 2.10. The other two piston crown bolts were still intact and can be seen at the bottom of figure 2.2.

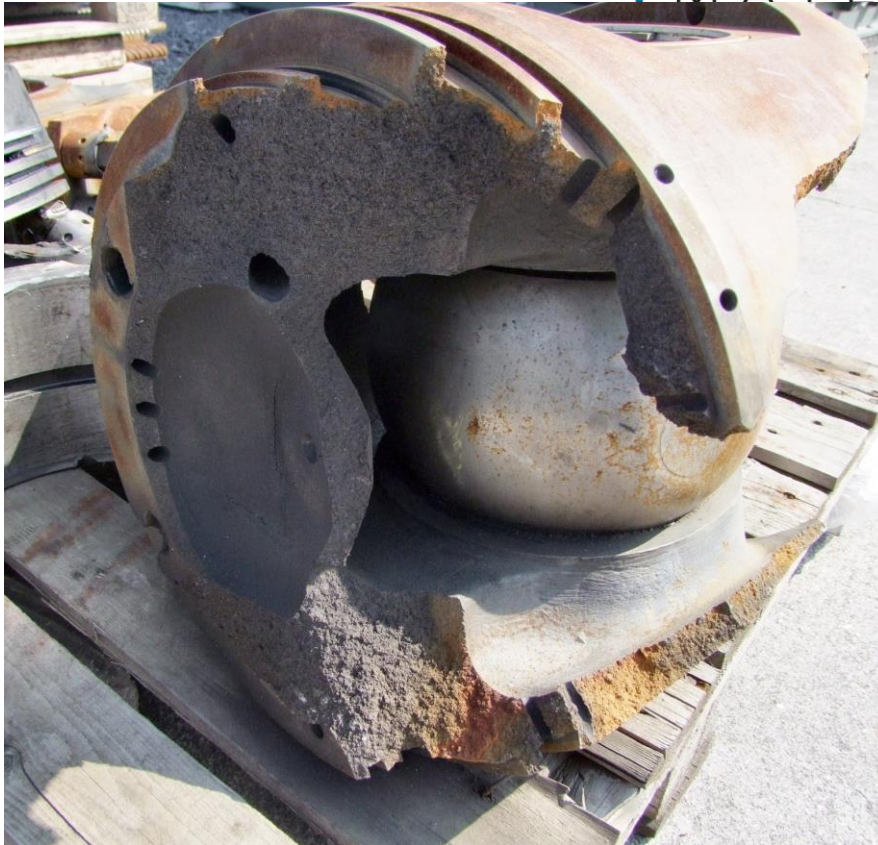
Figure 2.3 Lower part of piston - fracture face

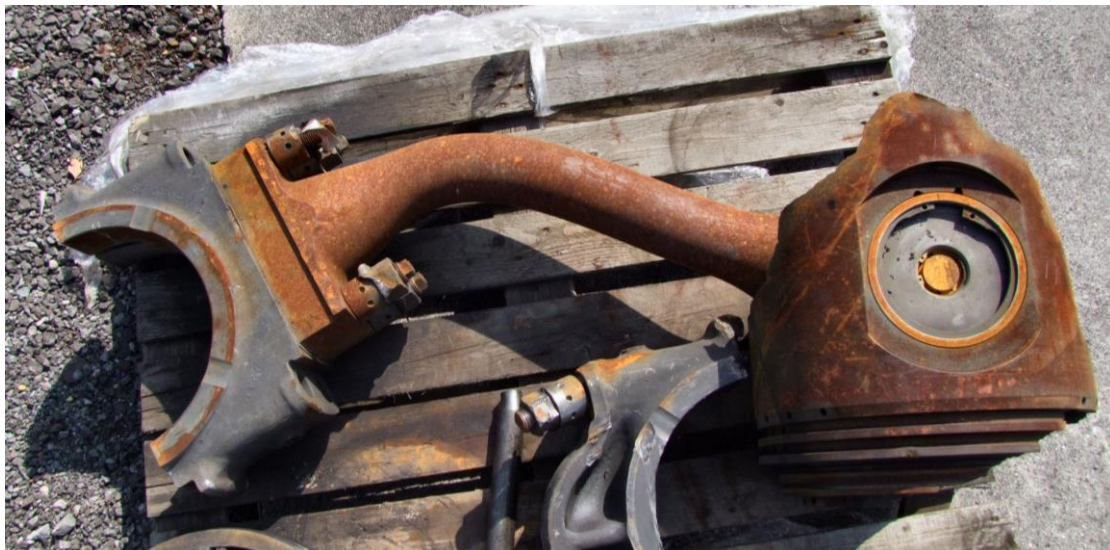
Figure 2.4 Bent conrod, part of big end, and lower part of piston

Figure 2.4 shows that the conrod had been bent by an angle of approximately 30° from being straight. Figure 2.5 shows that the bottom of the cylinder liner had been fractured when the piston broke through it. The bore of the liner shown in figure 2.6 did not reveal any gross scoring, although there was some lighter scoring present.

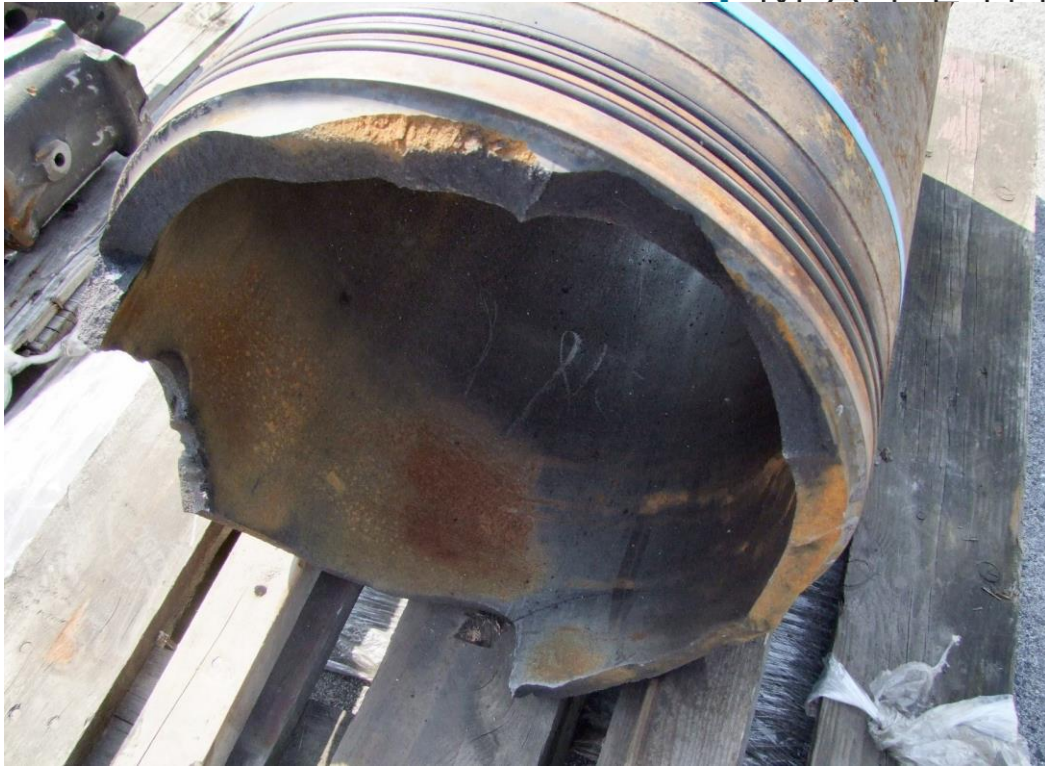
Figure 2.5 **Fractured end of cylinder liner**

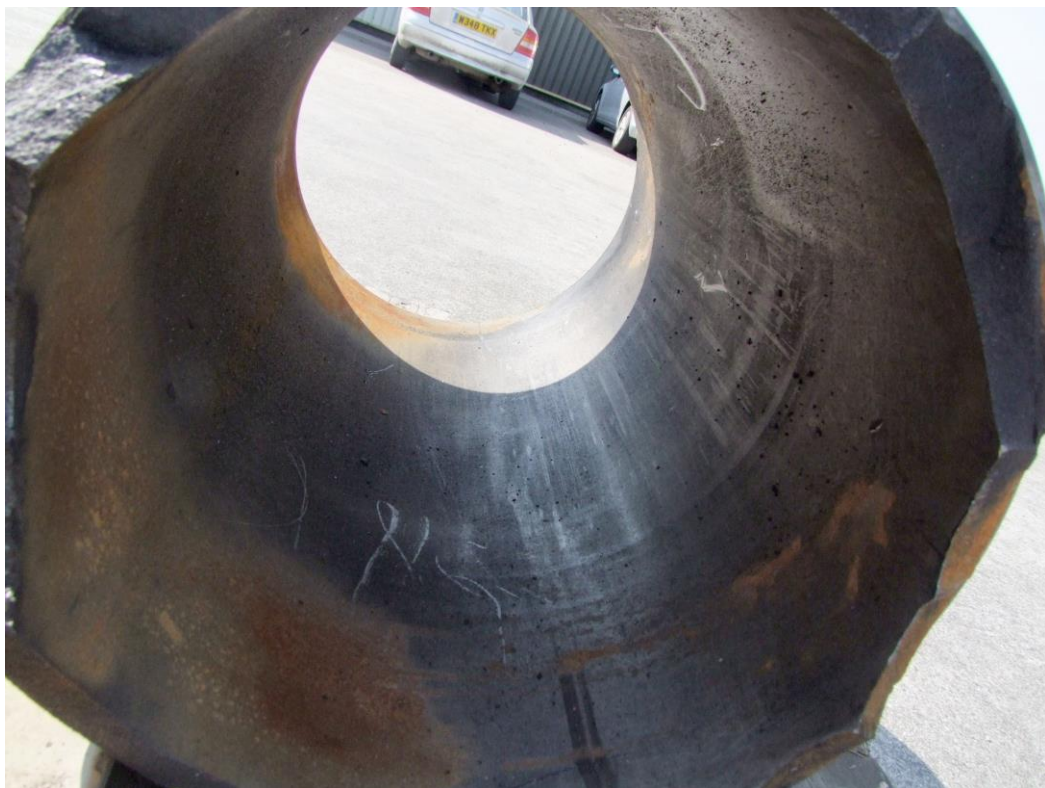
Figure 2.6 **Cylinder bore**

There was no substantial evidence of the piston having become jammed within the cylinder as only minor marking was present on the bore.

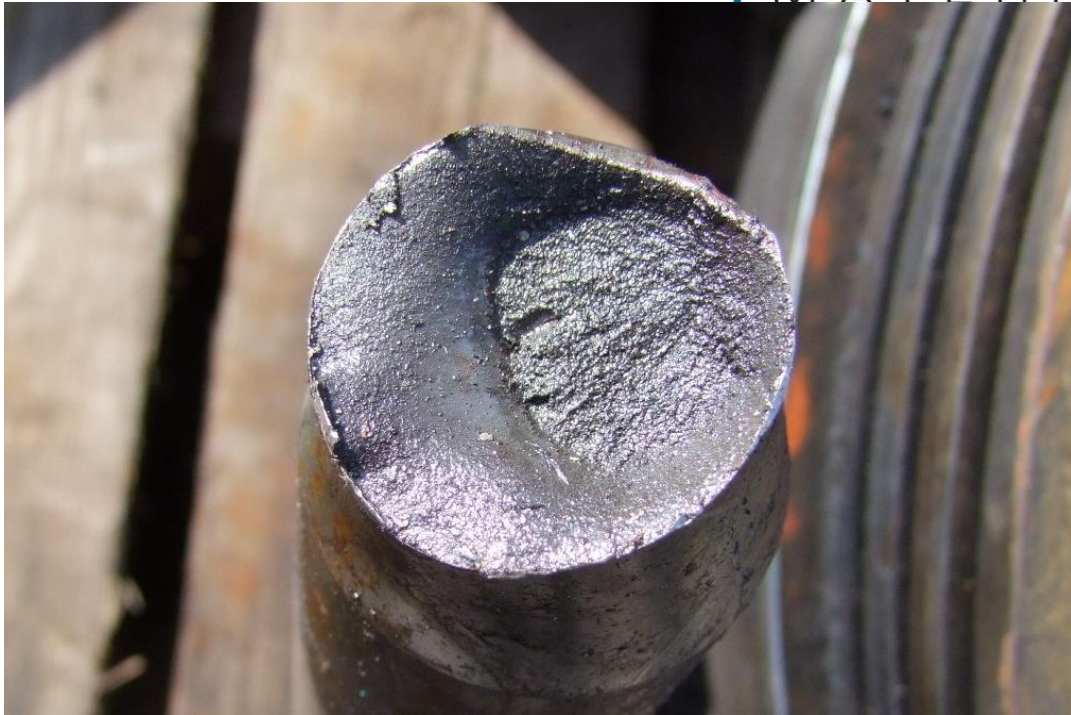
Figure 2.7 Big end bolt fracture face

Figure 2.7 shows the fracture face of the bolt, from the big end of the conrod, to have fractured in a tensile manner, with some bending present. There were other bolts remaining in the lower half of the big end that had also fractured in a tensile manner, one also showing some bending.

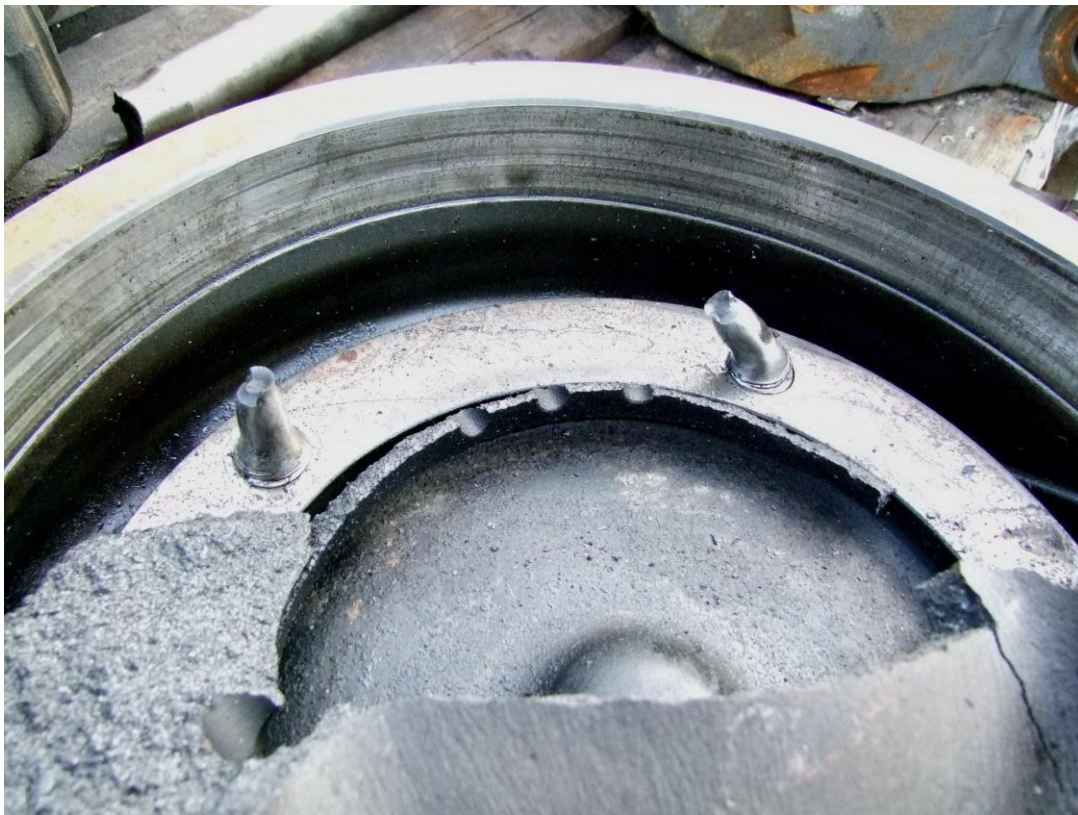
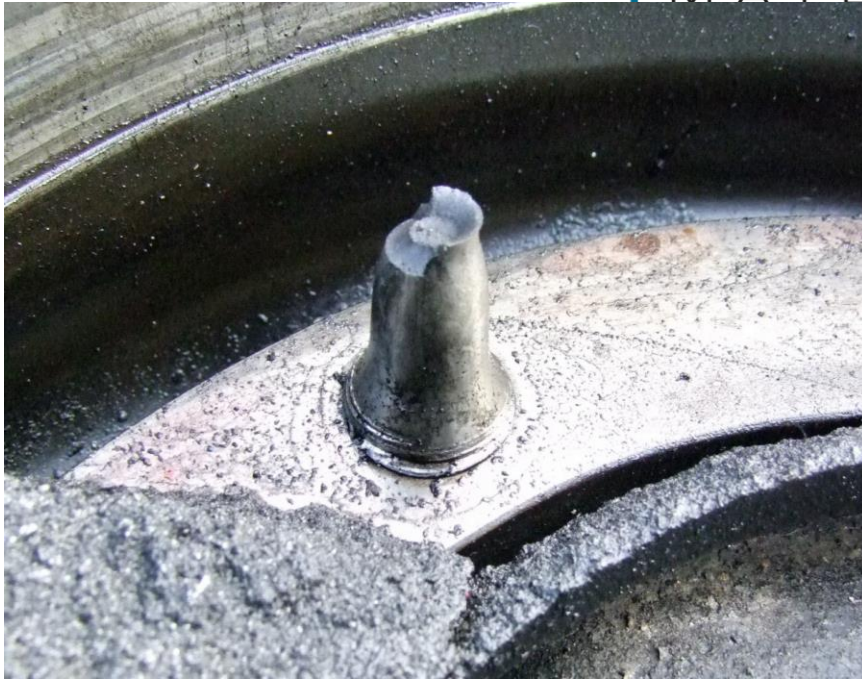
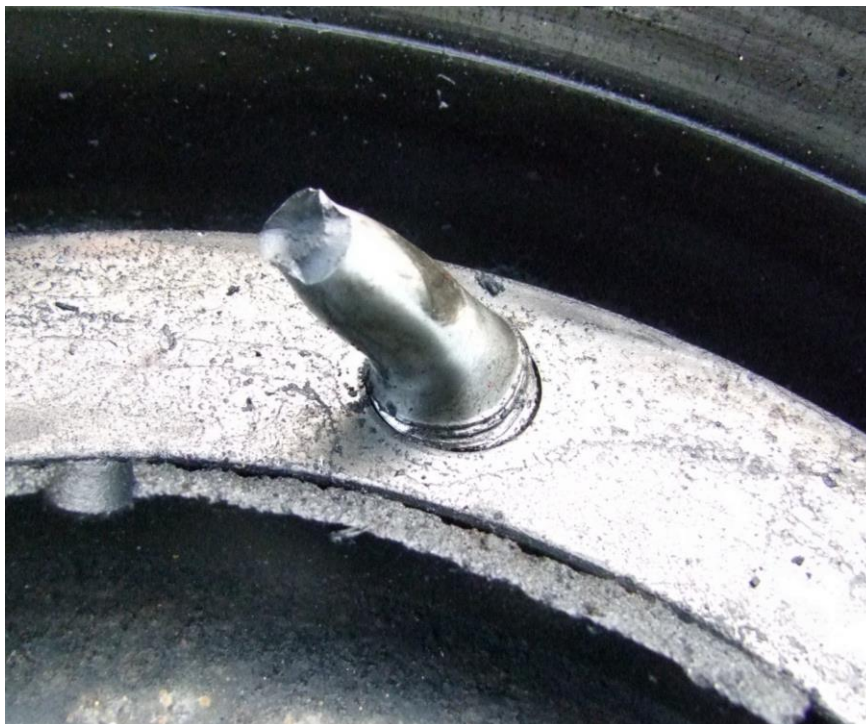
Figure 2.8 Piston crown studs 1 and 2

Figure 2.9 Piston crown stud 1

Figure 2.10 Piston crown stud 2

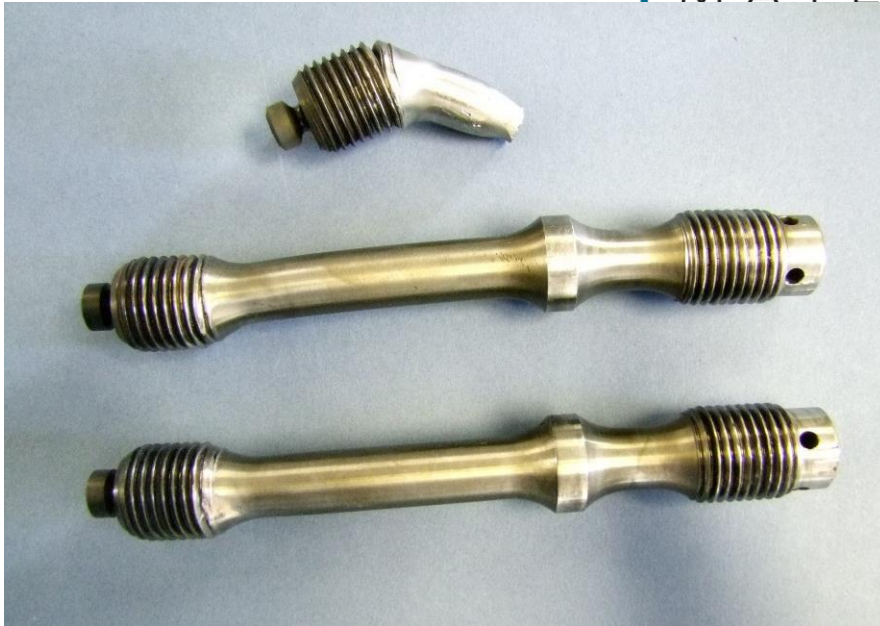
Figure 3.1 Piston crown studs after removal

Both of the ‘intact’ studs were slightly bent. A piece was also cut from the piston body itself, and this is shown in figure 3.2 below, where the fracture face is typical of that found at all positions.

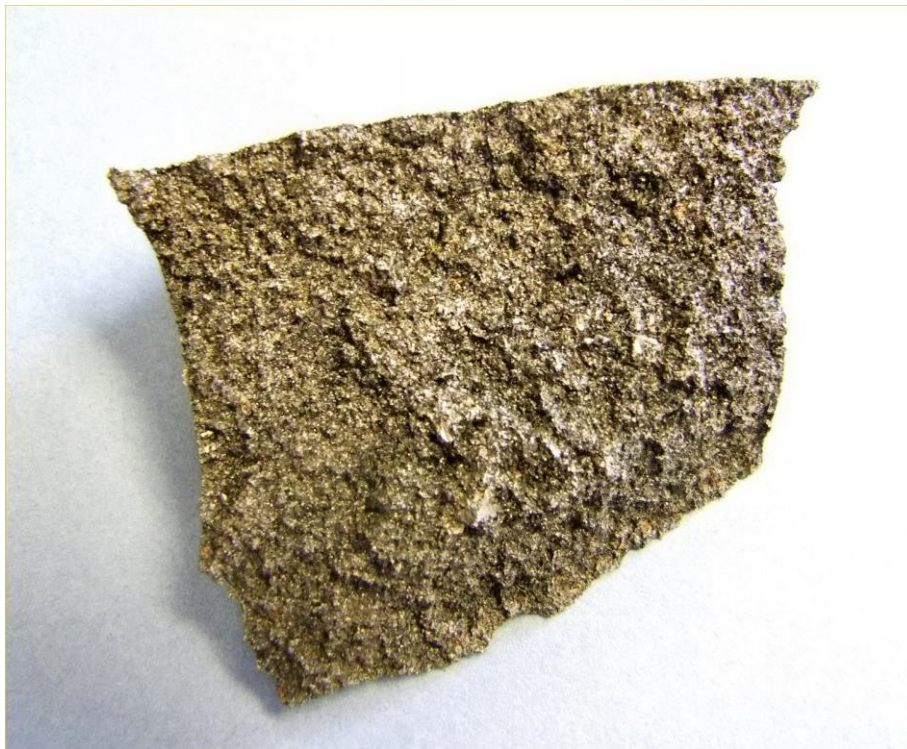
Figure 3.2 Piece of piston body

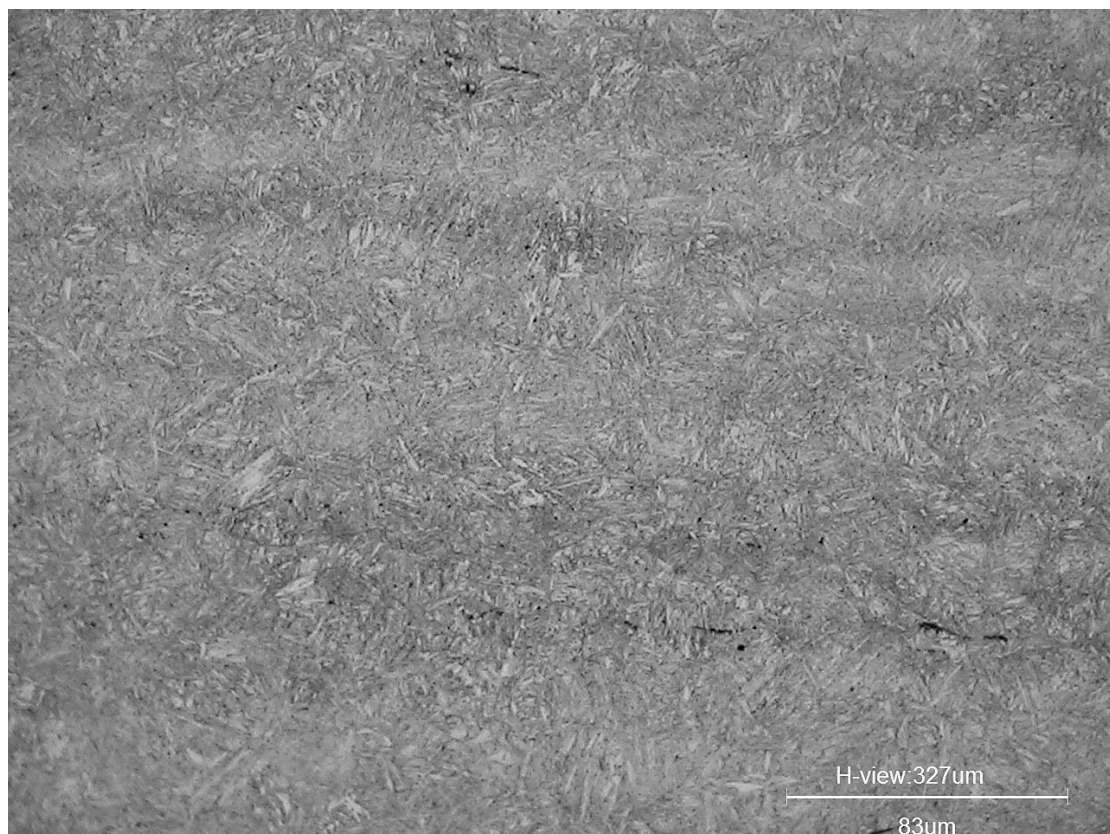
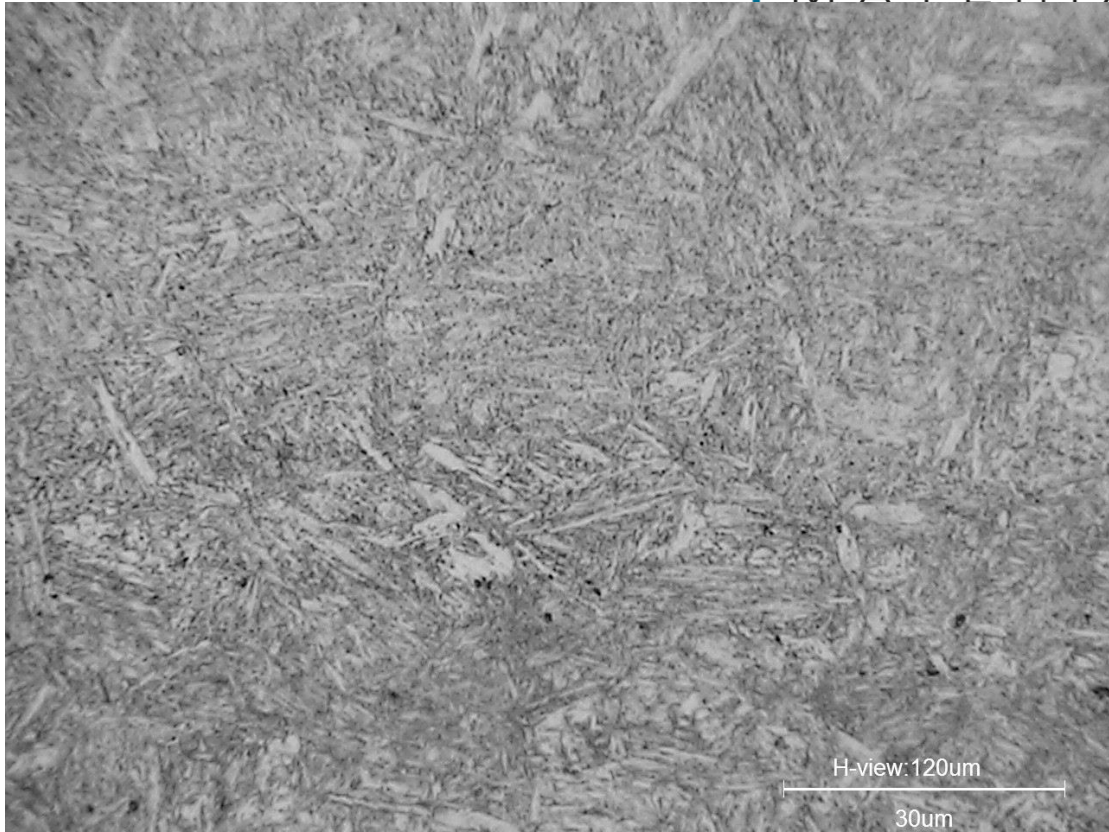
Figures 3.3 and 3.4 show the microstructure of a piston crown stud which consists of tempered martensite. The hardness of this microstructure averaged 322HV when measured on a Vickers machine to BS EN ISO 6507-1:2005 with a 10kg load, and is what would be expected in a steel of this type (see chemical analysis in section 6).

Figure 3.3 Piston crown stud etched

Figure 3.4 Piston crown stud etched

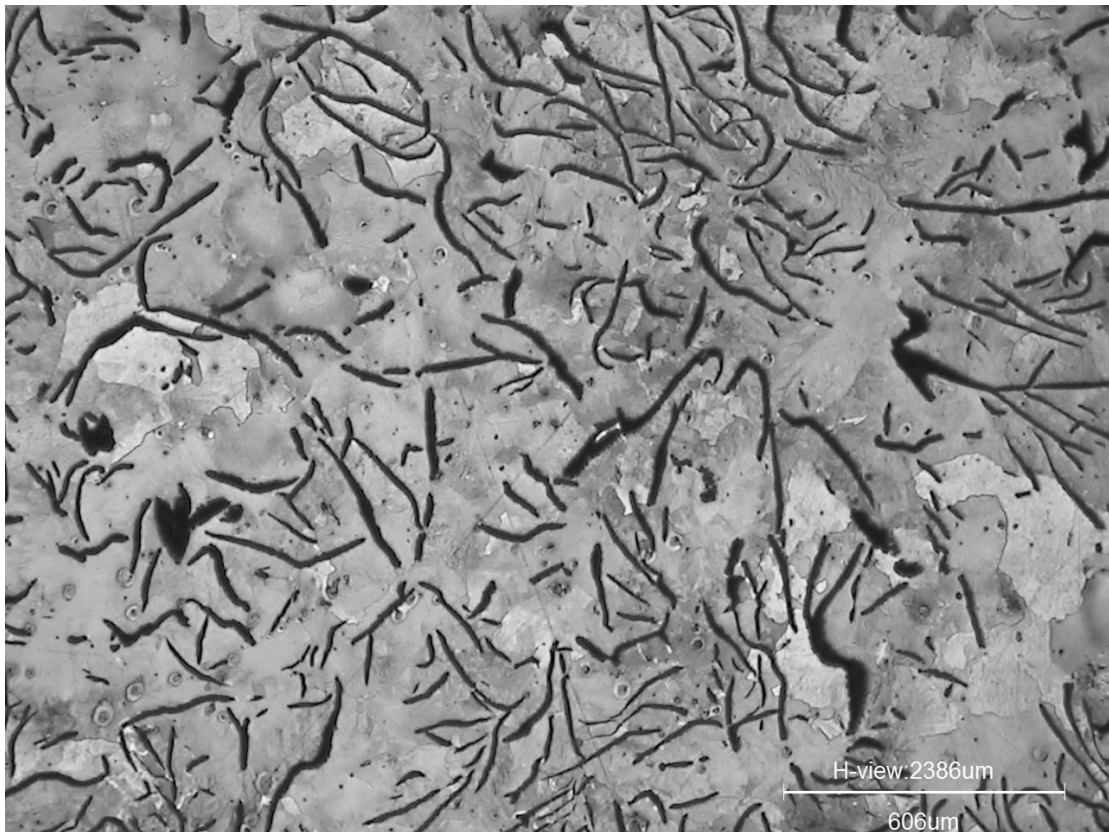
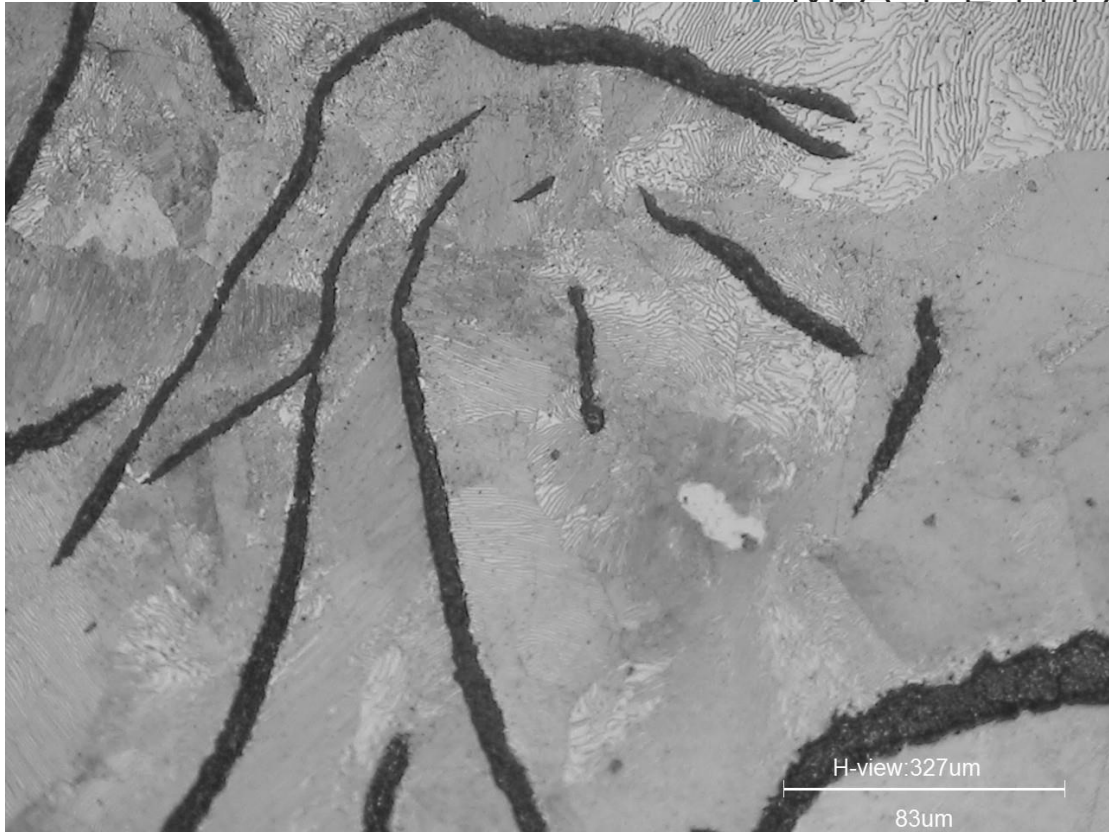
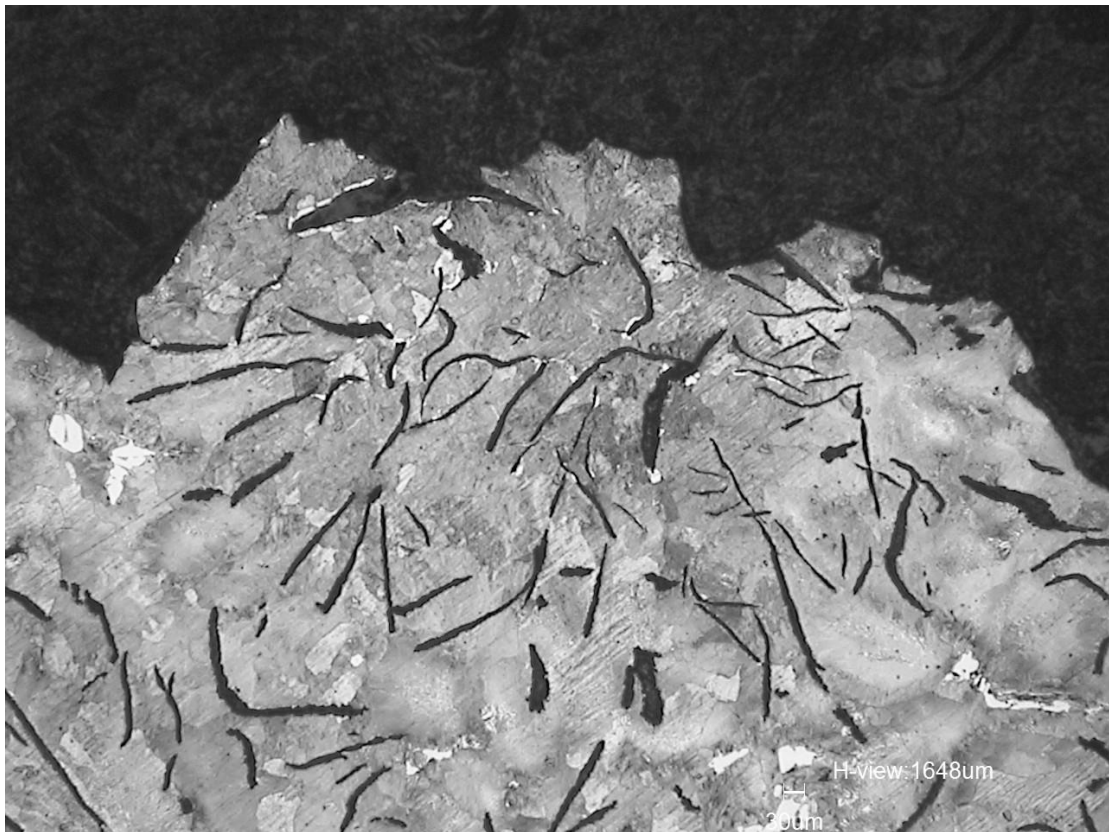
Figures 3.5 and 3.6 show the microstructure of the piston body in the etched condition. The microstructure is typical of a grey cast iron, with type A graphite flakes on the ASTM A247 grading system, in a matrix of pearlite. Figure 3.7 shows an example of the section across the fracture face of the piston body. There was nothing amiss with the type of fracture in this material, which is typical of a brittle fracture in cast iron. The hardness measurements averaged 191HV. If the grade of cast iron is similar to G3000 (see later in section 6) then this hardness meets the specification of 187 to 241HV.

Figure 3.5 Piston body etched

Figure 3.6 Piston body etched

Figure 3.7 Piston body fracture face etched

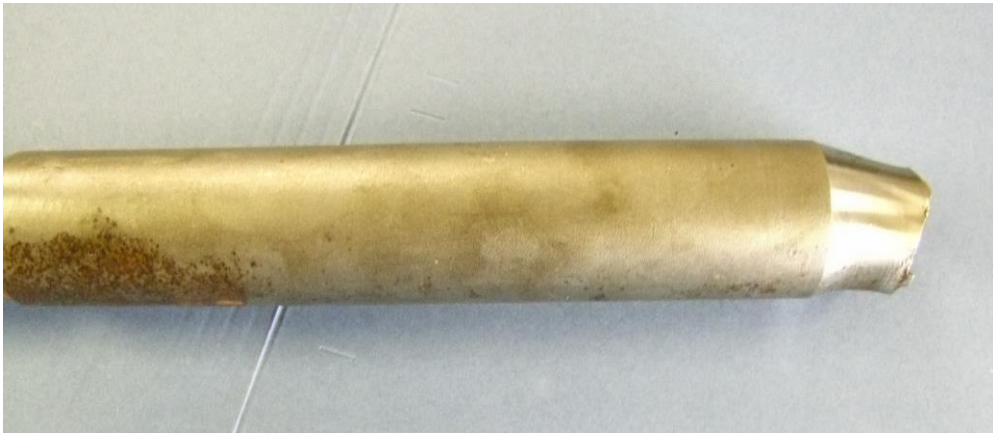
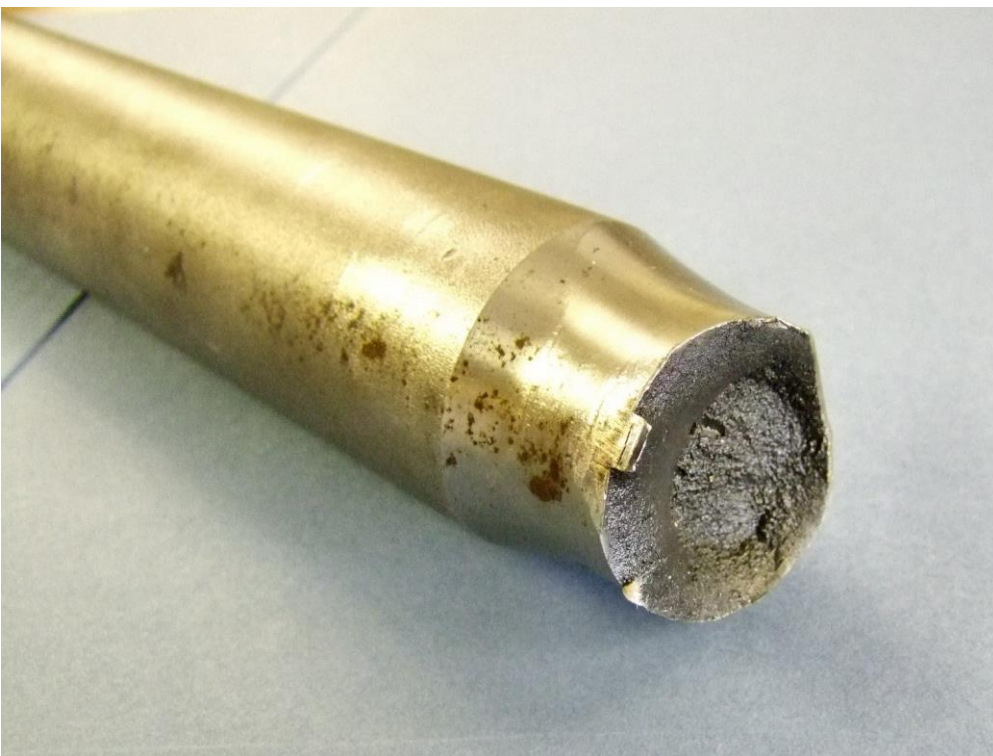
Figures 3.8 and 3.9 show one of the big end bolts that had failed in a tensile manner. This was sectioned longitudinally and prepared in the same manner as described above.

Figure 3.8 Big end bolt with tensile / bend type failure

Figure 3.9 Big end bolt showing the fracture face

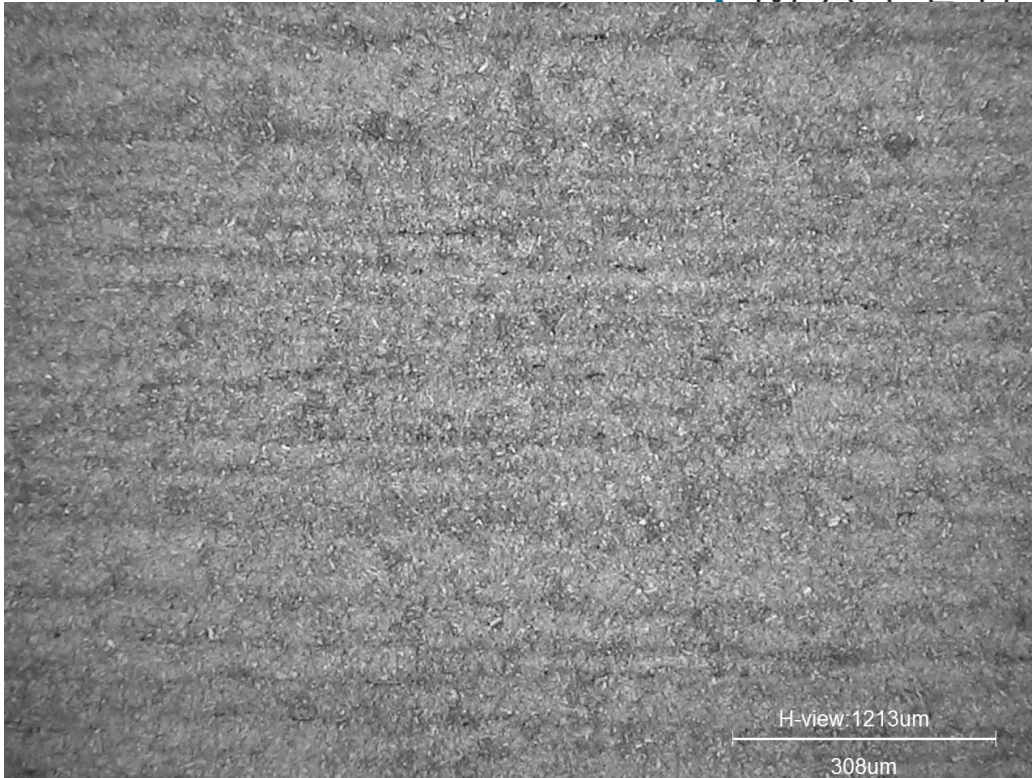
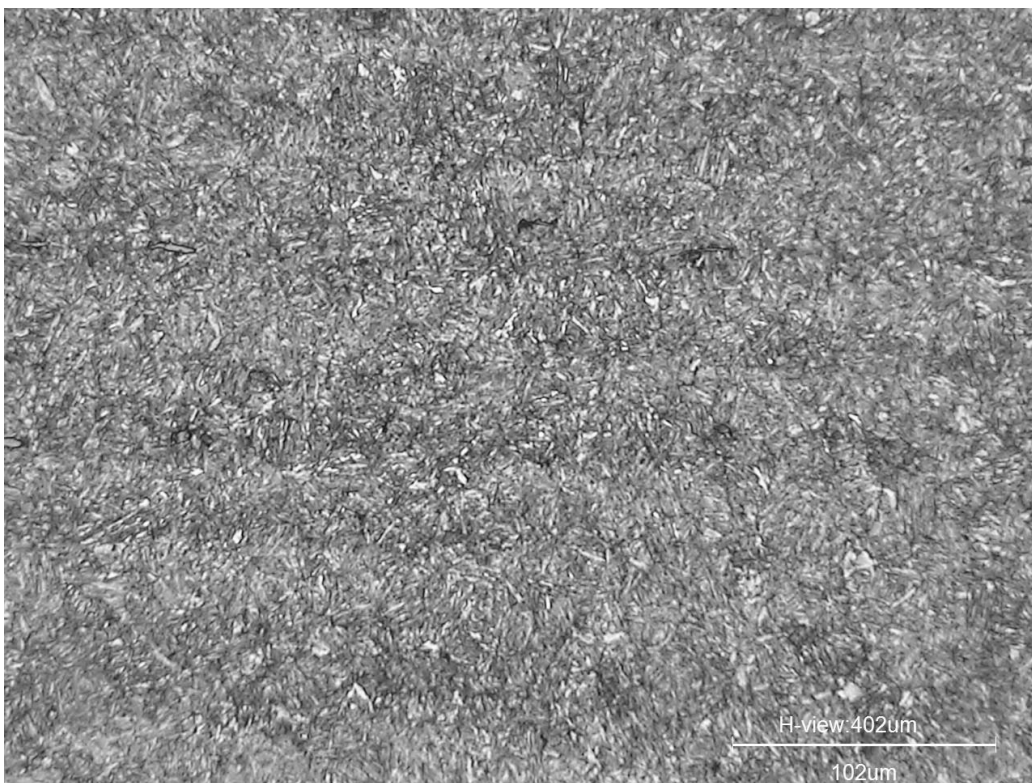
Figure 3.10 Big end bolt microstructure

Figure 3.11 Big end bolt microstructure

The microstructure of this big end stud consisted of tempered martensite. Hardness measurements on this gave an average result of 323HV, similar to the piston crown stud.

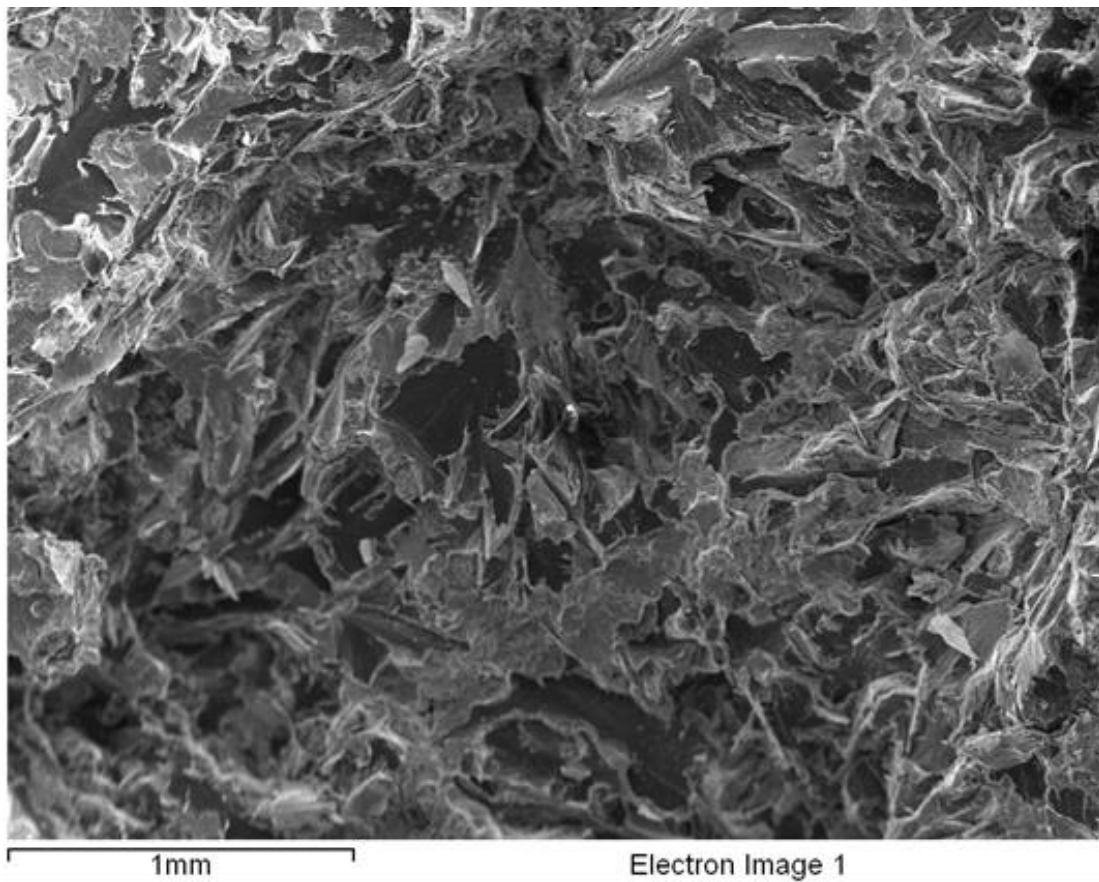
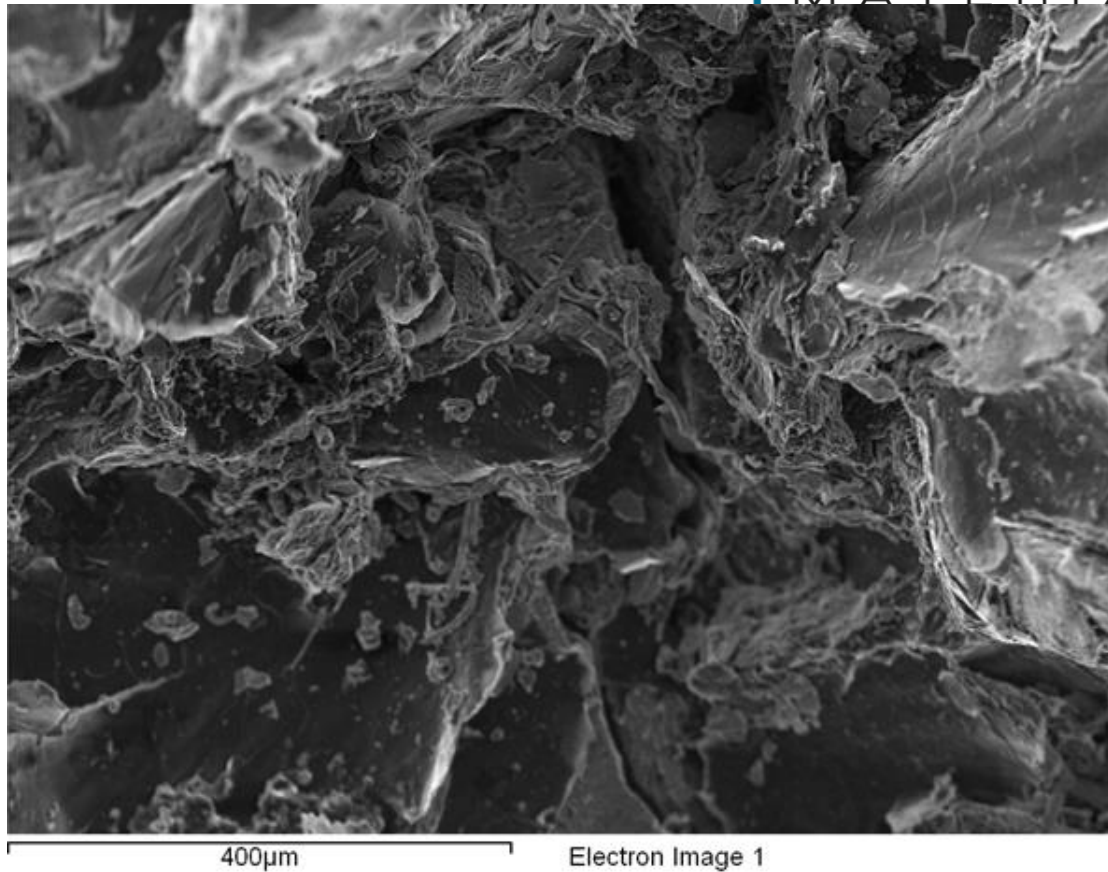
Figure 4.1 Typical fracture face of piston body

Figure 4.2 Typical fracture face of piston body

These show nothing untoward, appearing to show the flake graphite and pearlite within the microstructure.
