Examination of Components from a Failed Marine Engine

Report Number	M14191
Date	XXXXXXXXXXXXXXXXXXXX
Purchase Order Number	XXXXXXXXXXXXXXXXXXXX
Customer Reference Number	XXXXXXXXXXXXXXXXXXXX
Customer	XXXXXXXXXXXXXXXXXXXX XXXXXXXXXXXXXXXXXXXX XXXXXXXXXXXXXXXXXXXX XXXXXXXXXXXXXXXXXXXX XXXXXXXXXXXXXXXXXXXX
Customer Contact	XXXXXXXXXXXXXXXXXXXX

1. Introduction

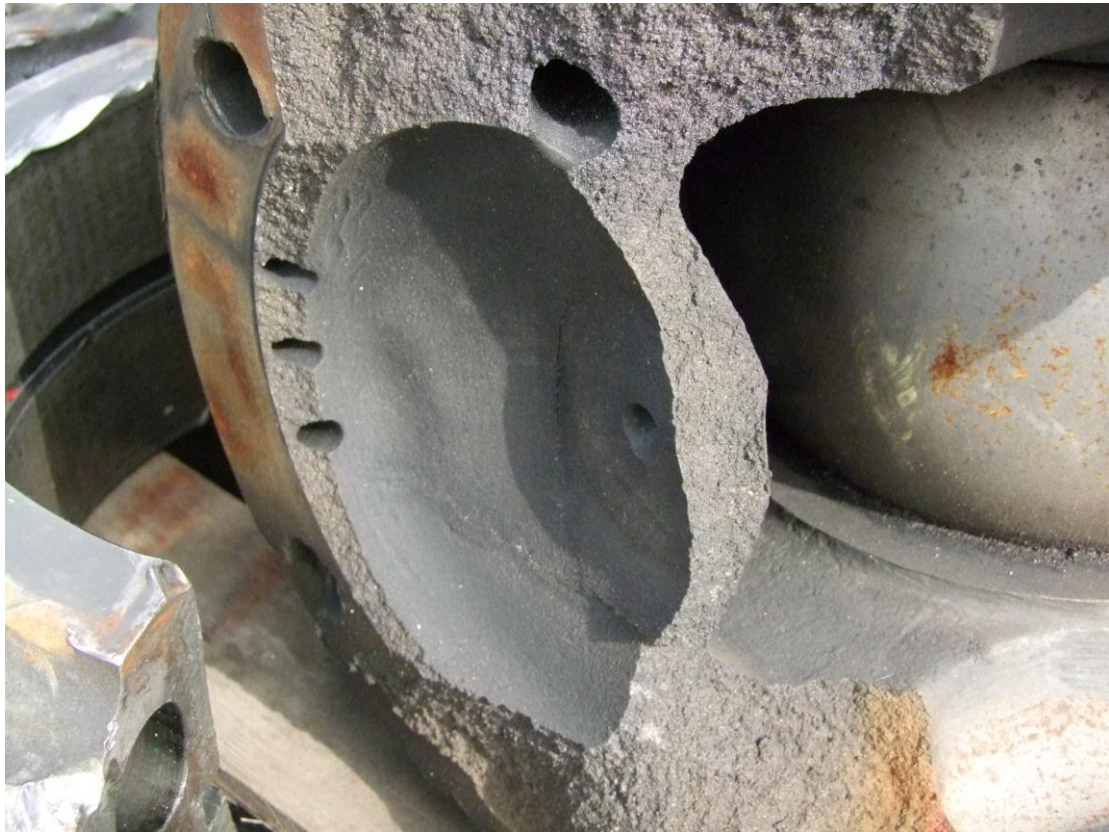
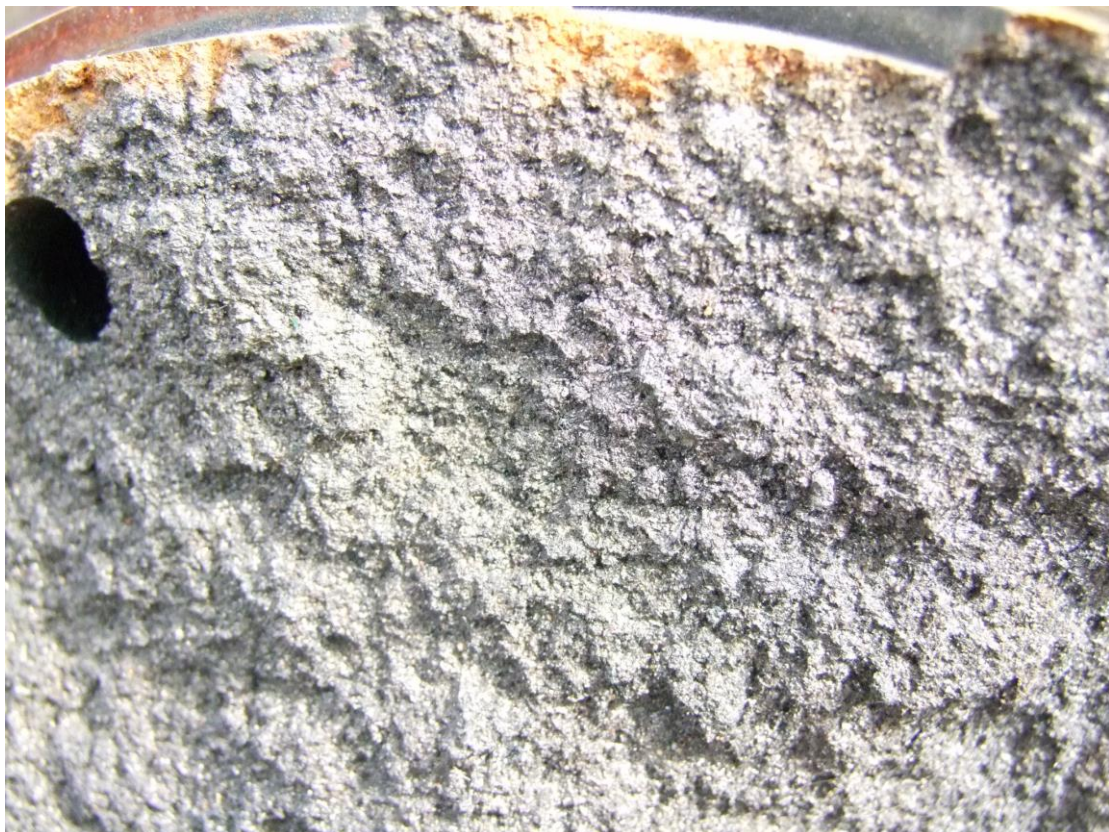
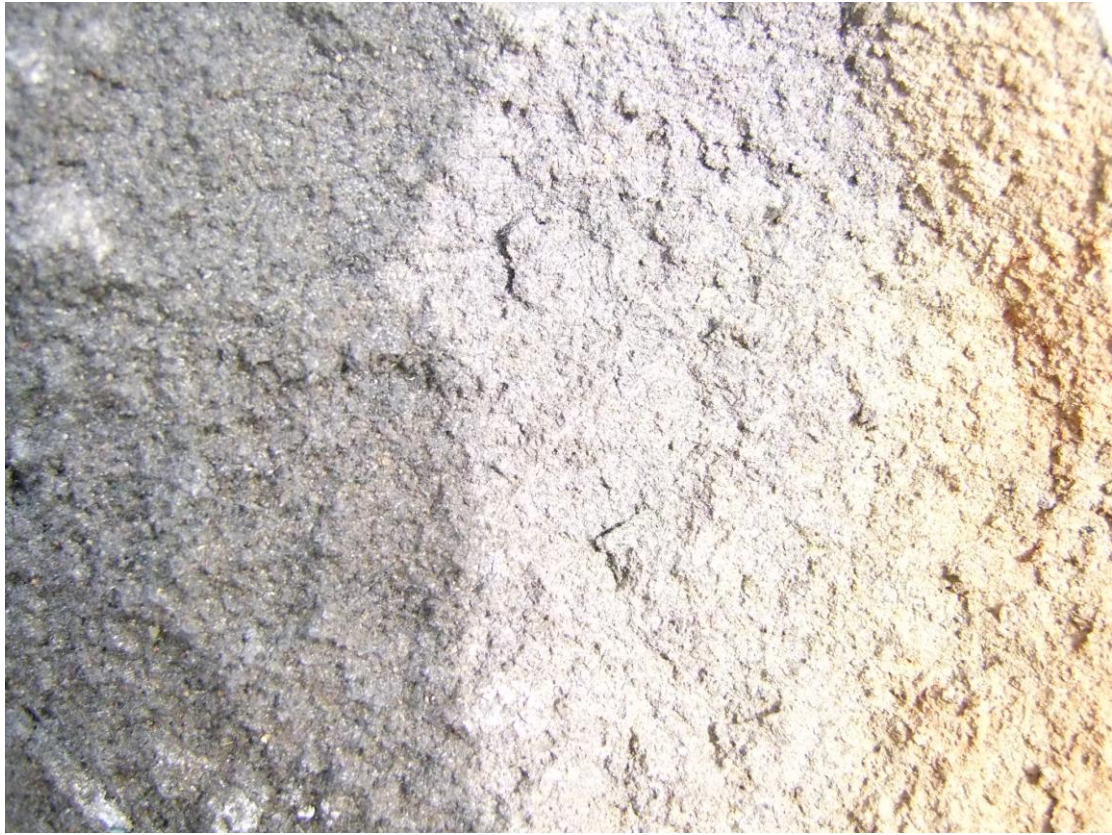
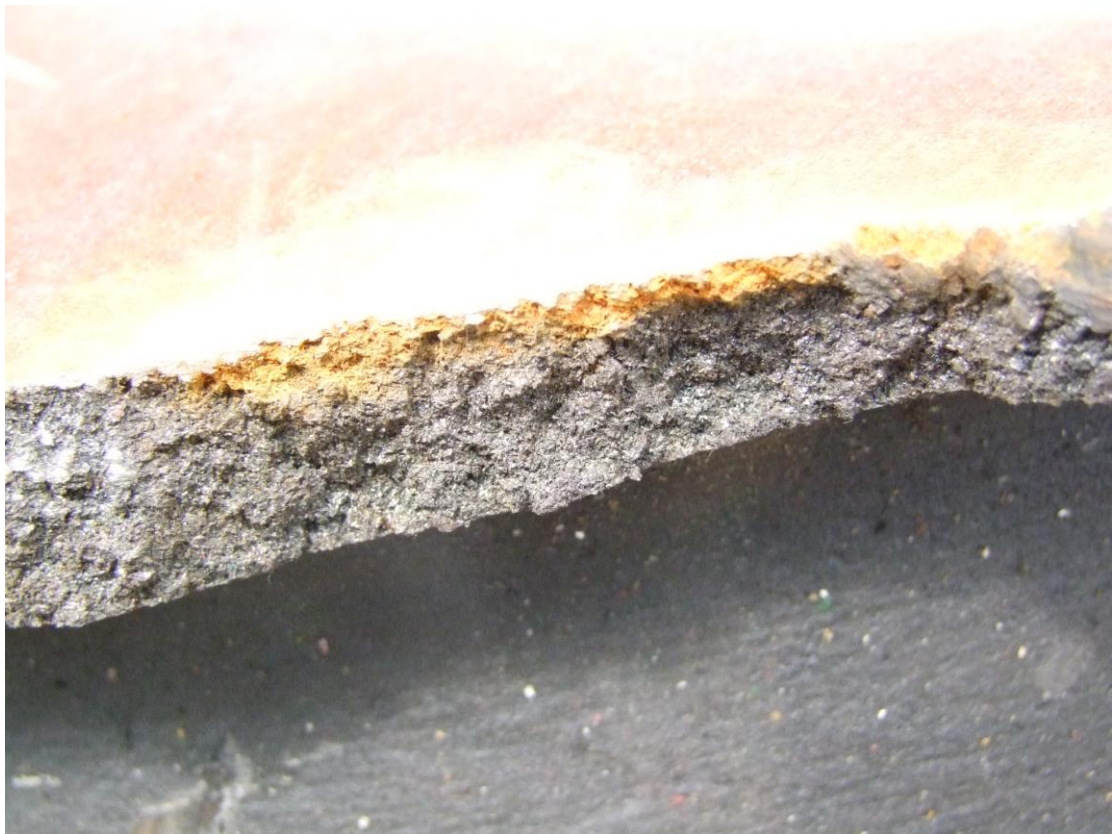
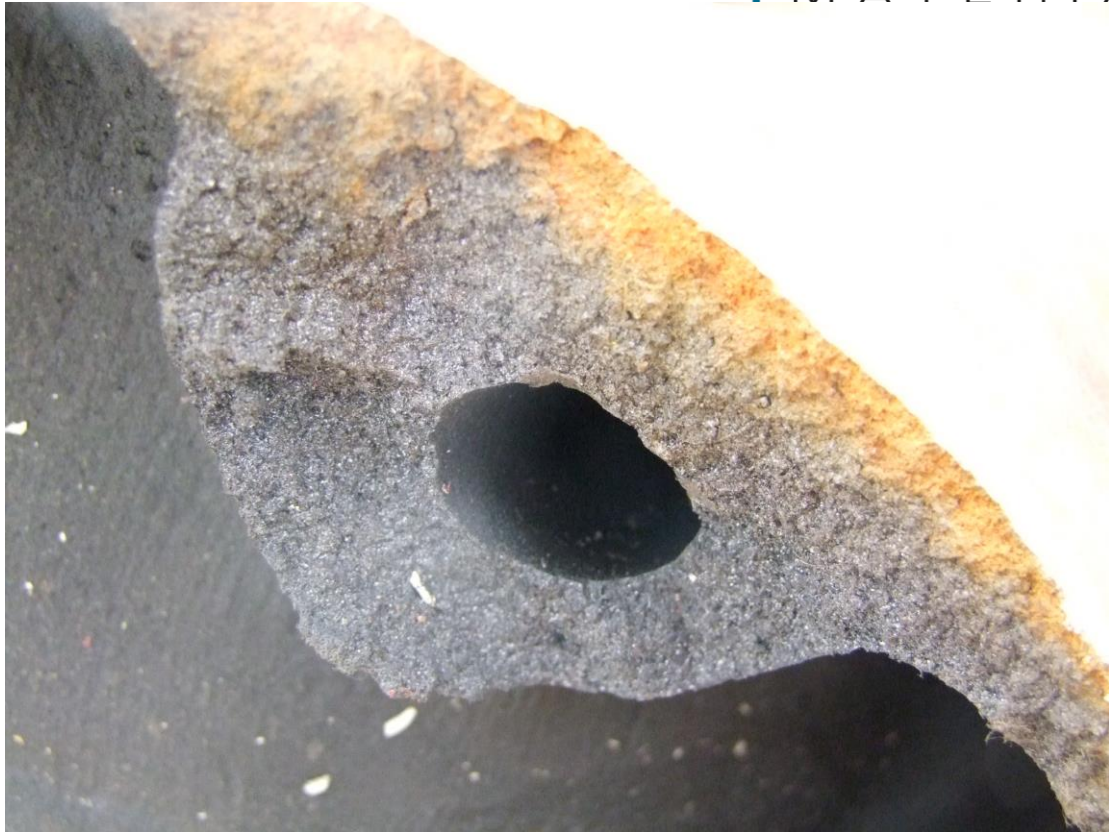
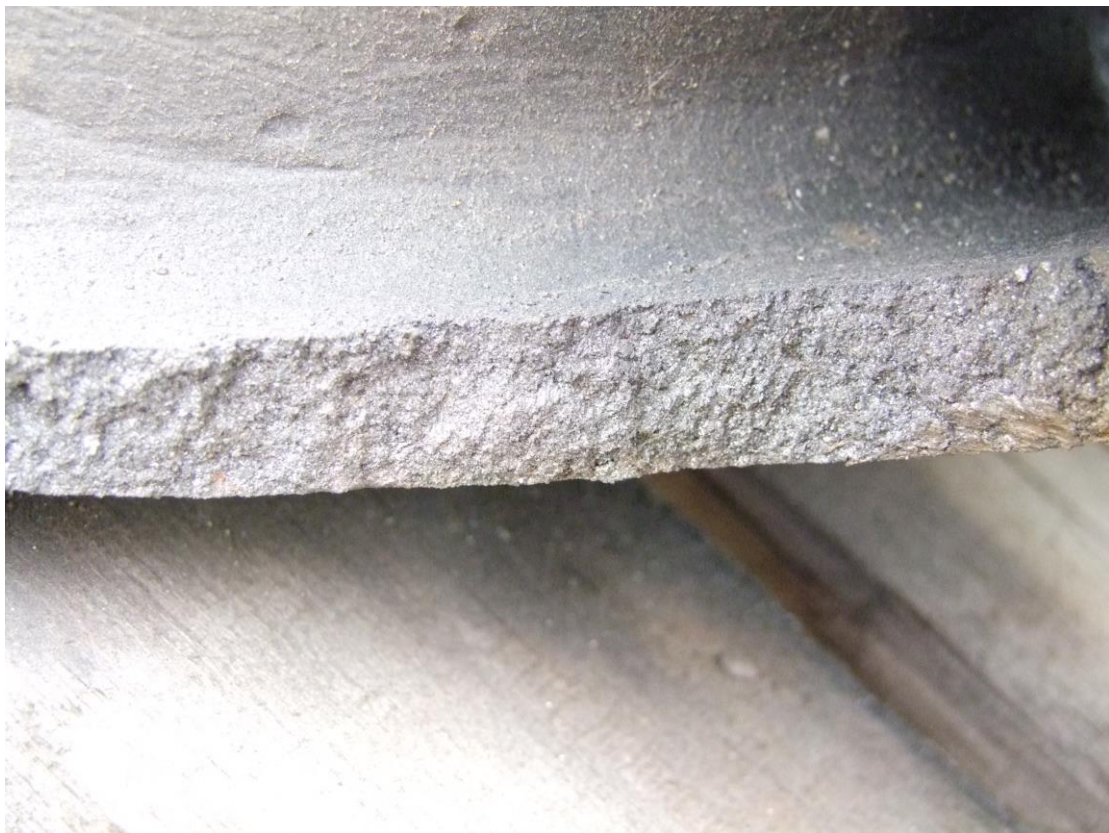
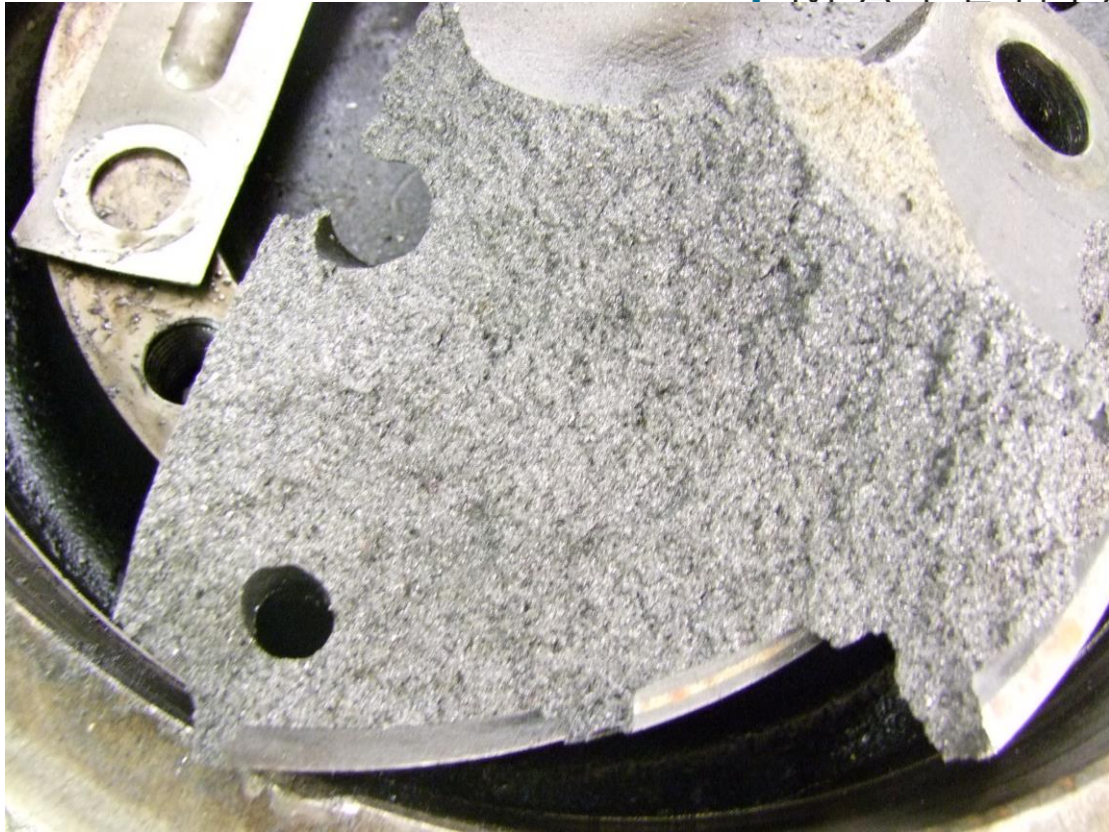
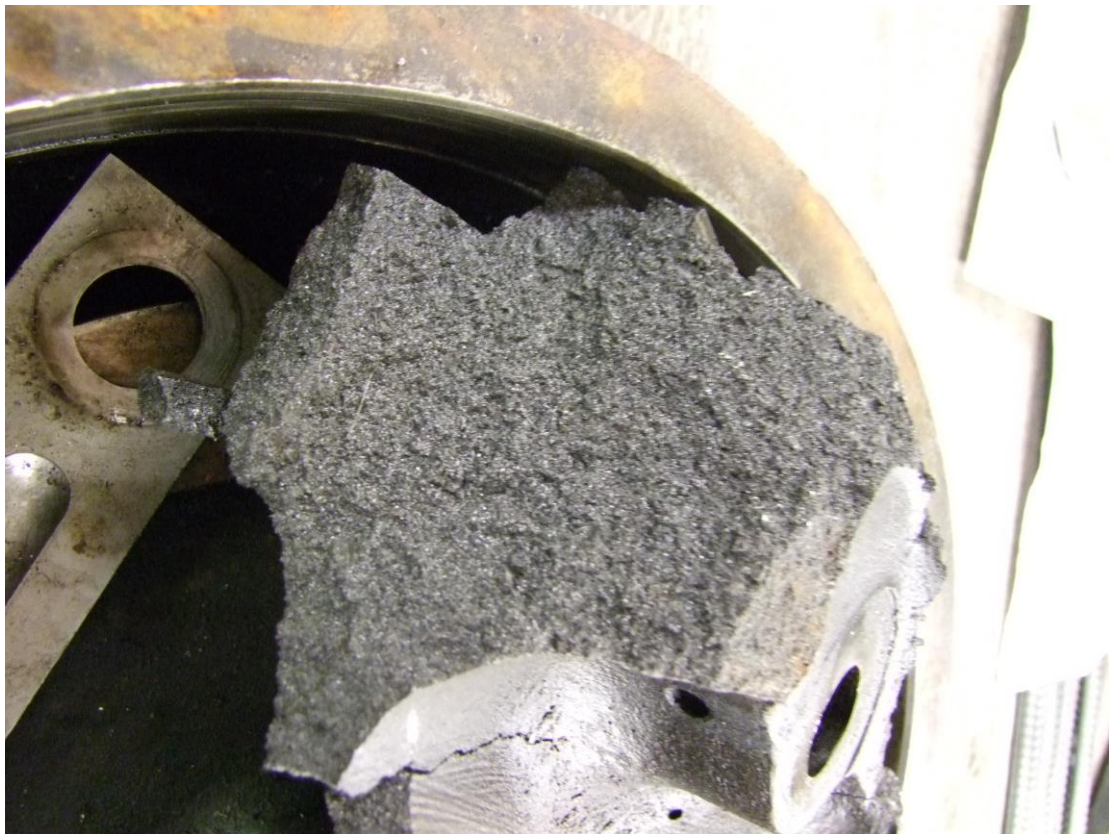
Appendix 1 Appearance of Piston Fracture Faces at Eight Locations

The fracture faces on the piston body were examined at all locations, and appendix 1 shows examples of the appearance at eight different positions. It can be seen that the fracture appearance is similar in them all. There was no evidence of any fracture facets that would suggest that some of the fracture had been present for a longer time than others. There was some rust present at some positions, but on the matching faces of the fracture of the piston body still attached to the piston crown, rust was not present. This rust had therefore formed since the failure.
